## Cleaning of Intersleek<sup>®</sup>700 using Caviblaster Equipment at HMS Naval Base Devonport

Trevor Solomon, Intersleek Senior Product Manager

### Summary

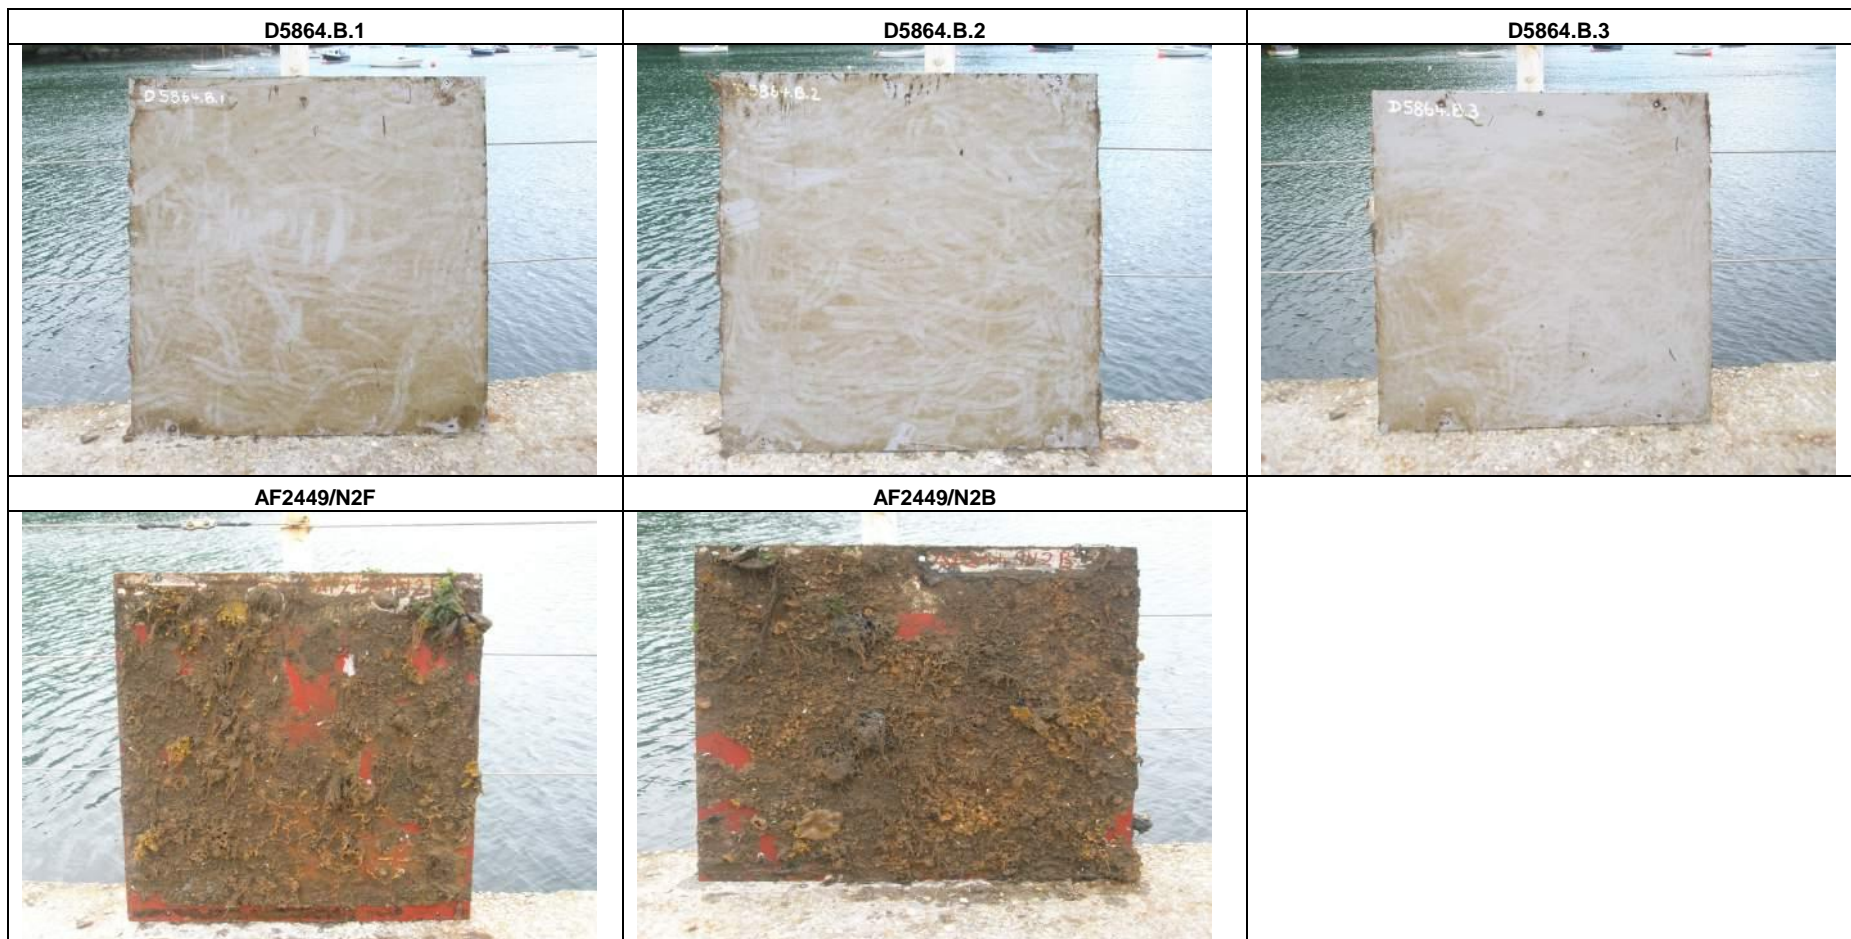
Panels D5864.B.1, 2 and 3 all had a light biofilm.

Panels AF2449/N2F and B had heavy coverage of various fouling organisms (bryozoan, sponges, hydroids, tubeworms, barnacles, muscles and limpets).

D5864.B.1	Purposefully prepared for the trial and immersed at Newton Ferrers for 1 month
D5864.B.2	
D5864.B.3	
AF2449/N2F	Selected from redundant test programmes that had been immersed for 5 years at Newton Ferrers
AF2449/N2B

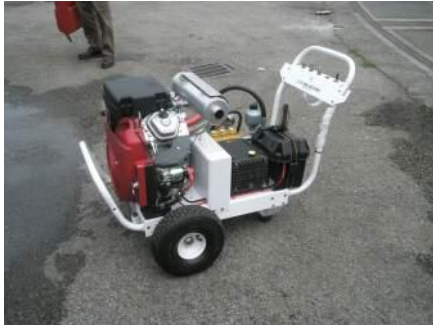
Compressor

The equipment used was the 2,200 psi petrol model.

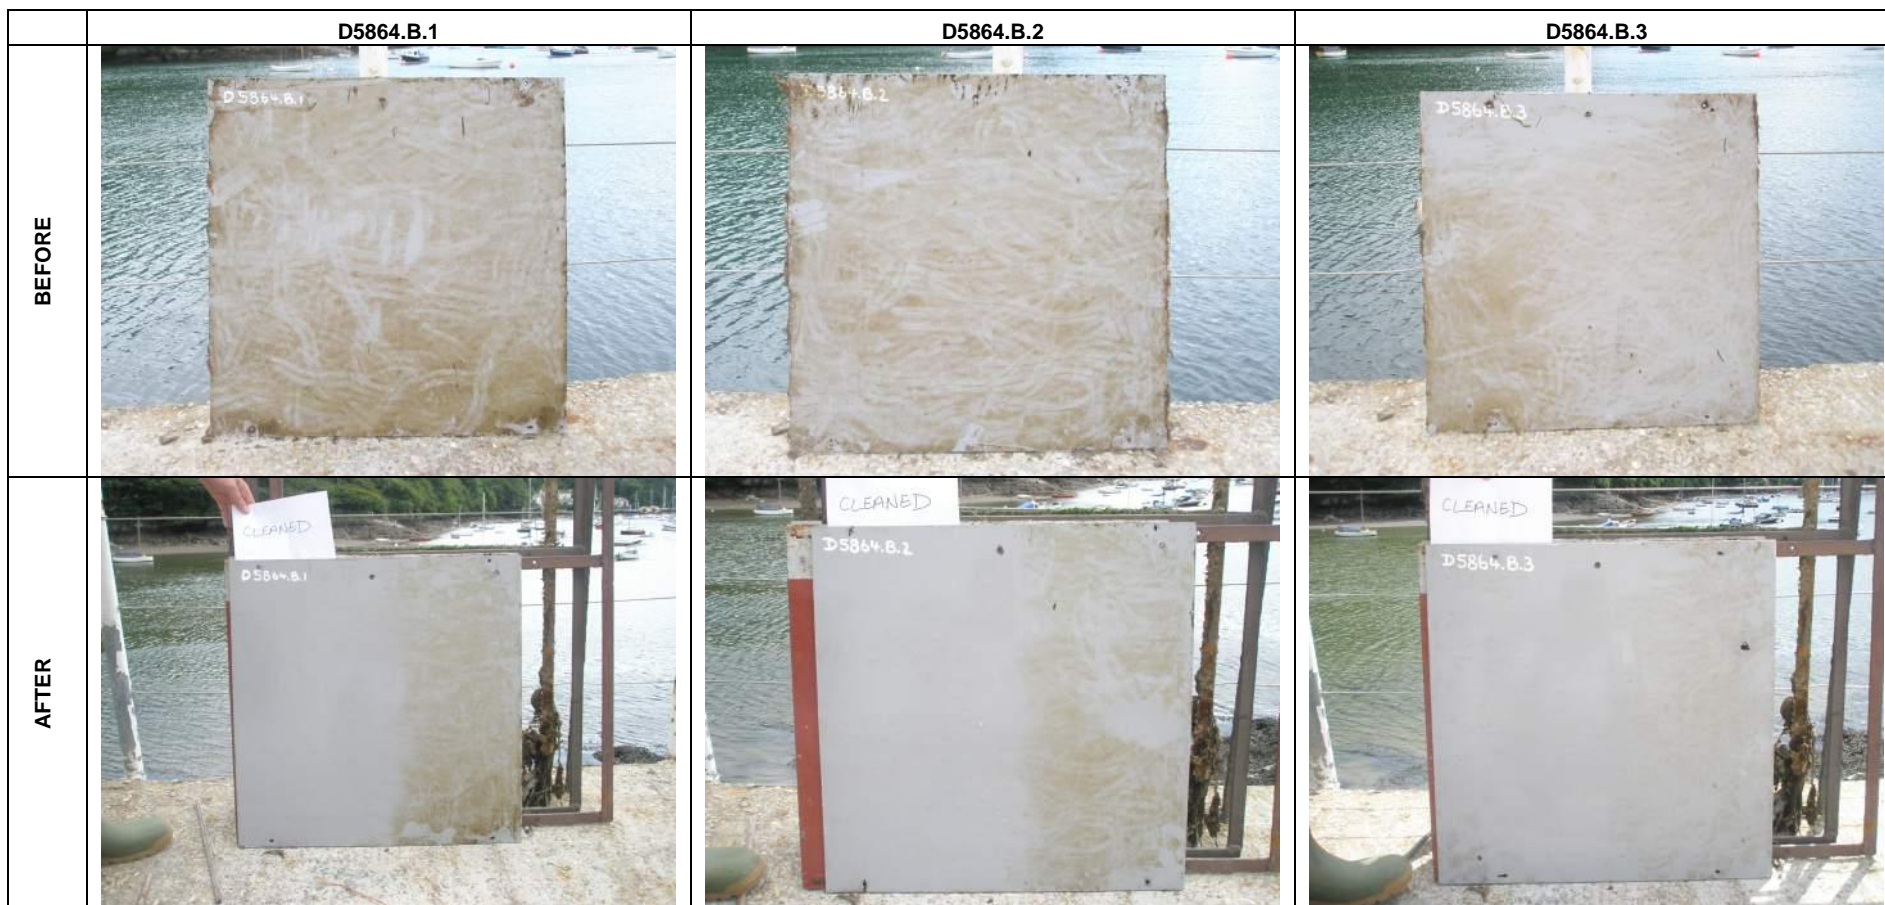
Unsurprisingly, the Caviblaster equipment was slow and struggled with removing the biofilm. However, with practice and through making slower and more passes, the diver was able to remove more of the biofilm. At the speeds necessary though, everyone agreed that this would not be a commercial option for removal.

As each panel was cleaned, the half of the panel cleaned was visually assessed for any signs of damage; none could be found.

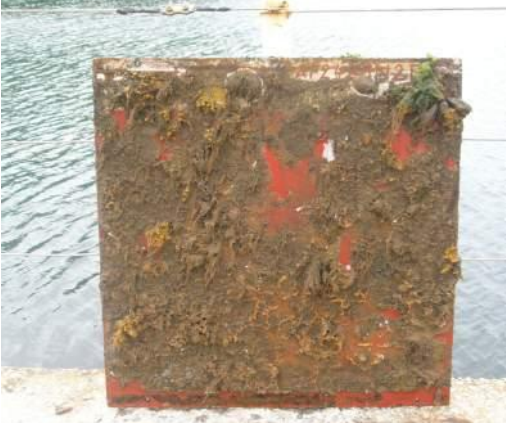
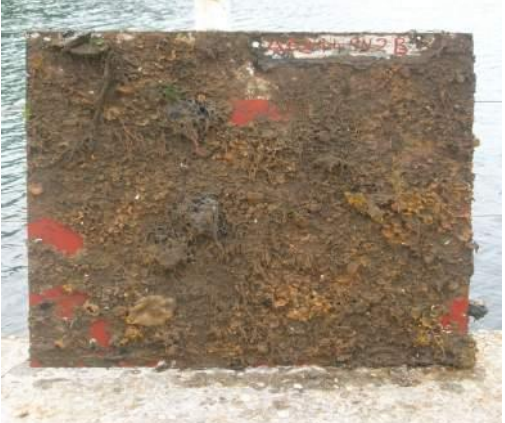
AF2449/N2F	AF2449/N2B
<b>BEFORE</b>

The fouling removal from these panels was very quick, due in part to the ability of the Intersleek® systems to inhibit strength of adhesion of fouling and the equipment itself.

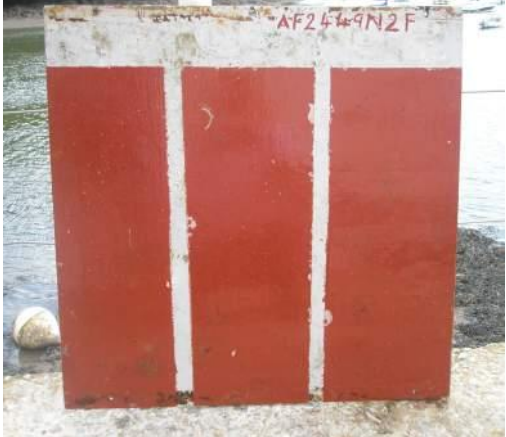
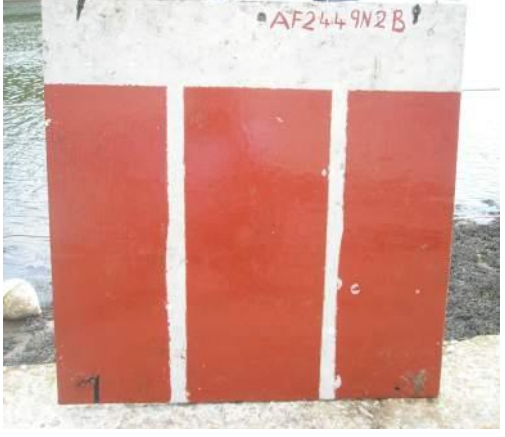
<b>AFTER</b>

Though not measured, it is estimated that one panel was cleaned in less than 20 seconds.

After cleaning, the panels were visually assessed for damage; as previously, none could be found that could be attributed to the cleaning equipment.

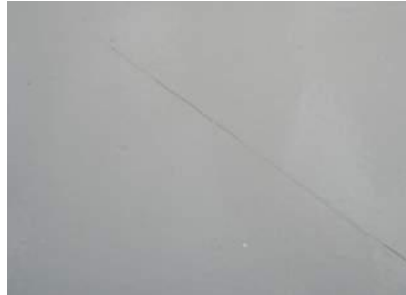
As the Caviblaster equipment appeared unable to damage Intersleek®, a further panel was purposefully scored completely through to the plywood using a knife and the diver was instructed to try and remove the coating. After five minutes, it was apparent that the equipment would not remove any of the coating away from the damage areas.

A spare panel was purposefully scored using a knife and the diver instructed to try and remove the coating using the cavitation equipment. The purpose was to mimic cleaning of damaged coatings on underwater hulls. The equipment failed to remove any of the coating.
